PEAKIRK CONSERVATION AREA APPRAISAL

REPORT AND MANAGEMENT PLAN

Prepared by: Planning Services, Peterborough City Council

Date: August 2010

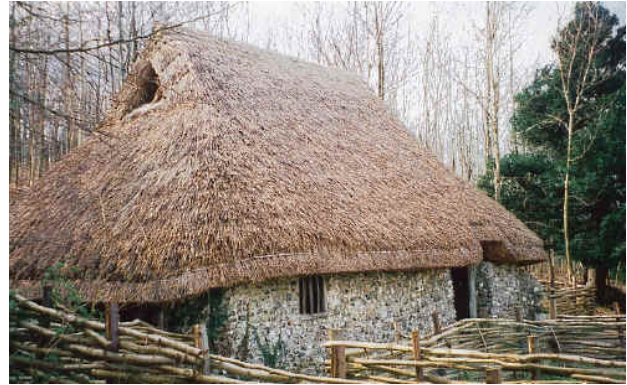
The cottage illustrated right is a 13th century dwelling reconstructed at the Weald and Downland Museum, Sussex. Similar Cottages in the Nassaburgh Hundred (old administrative area) would have had timber framed walls with wattle and daub infill panels.

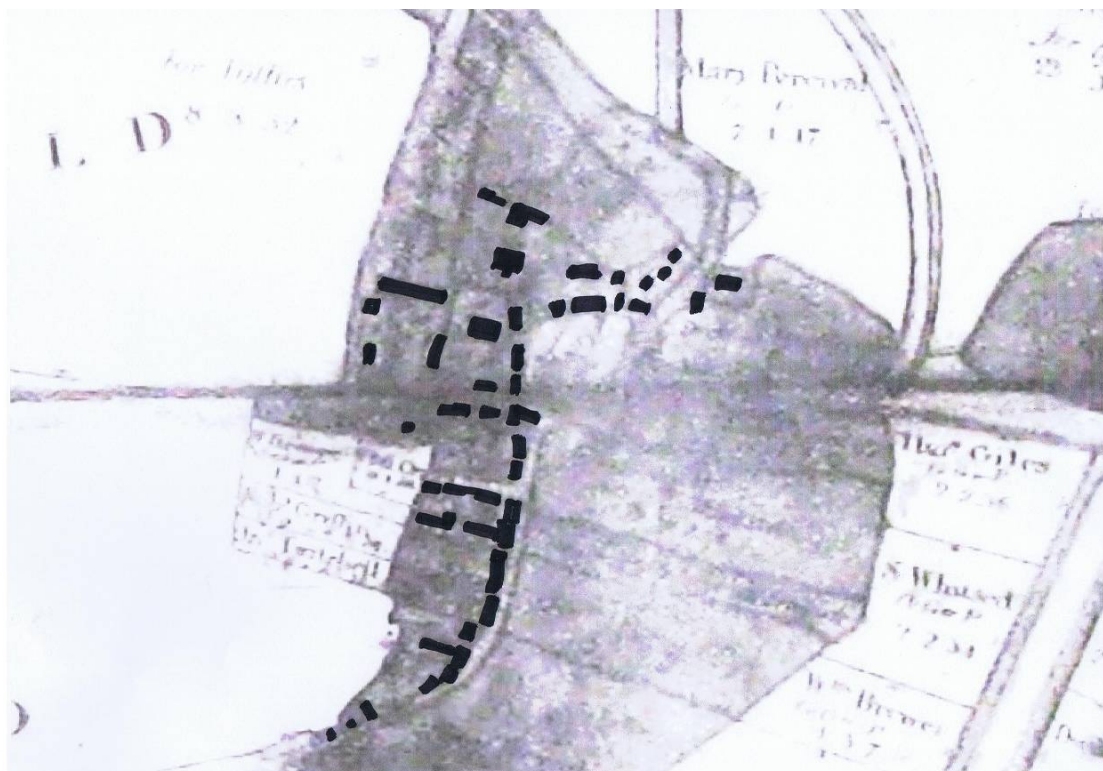
The map below is an enlarged copy of the Enclosure Map of 1819 (Annexe 1.2) with the buildings that can be readily identified, shaded black. This shows Peakirk as a fairly nuclear settlement but with an almost continuously built up frontage to the west of the St Pega's Road, as far as Greystones House.

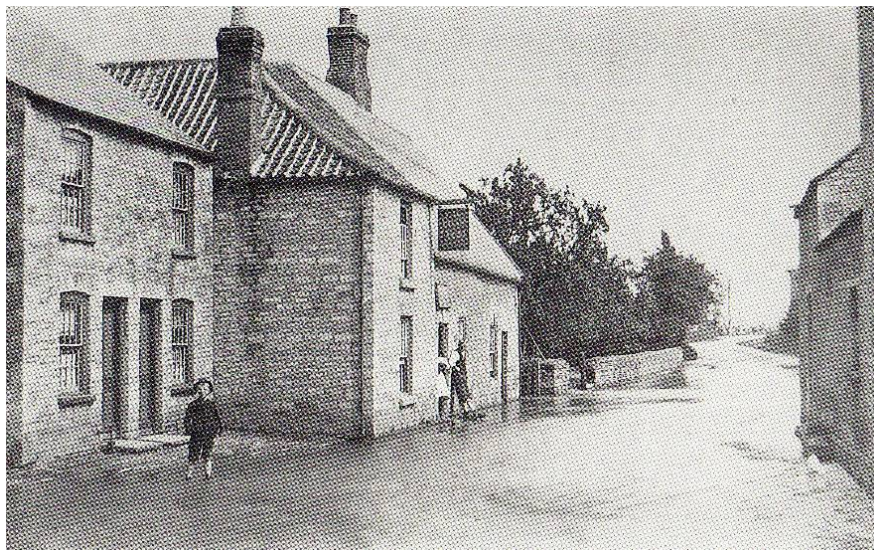
In the photograph of Gatehouse Road (now Thorney Road), the public house (the Boat Inn) is clearly a one and a half storey thatched structure with an early 17th century central chimney. The pantiled addition appears to be date from the mid 19th century whilst the semi-detached cottages to the left foreground are early/mid 19th century. The buildings to the right hand foreground in rubble and Collyweston slate are 18th century and still exist. The name "The Boat Inn" may give a clue as to the significance of river transport right into the early 20th century.

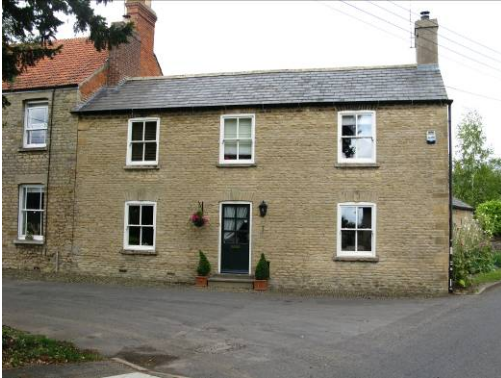
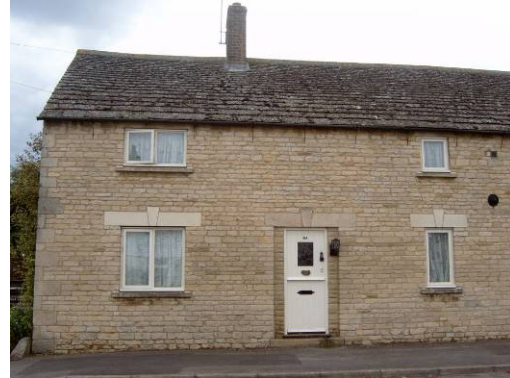
Earlier 19th century buildings continue the 18th century tradition of stone and sash windows, arranged in a 3 bay form with a central front door. Shallow pitched roofs mean there are no longer attics

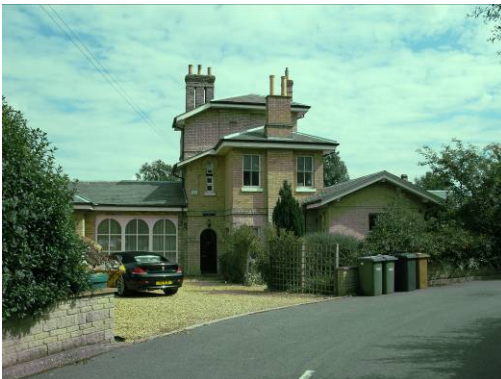
The Station is a typically exuberant Victorian combining machine made bricks, Welsh slates and sash windows in a Gothic approach to architecture. The goods shed reflects the 19th century increasingly technological approach to buildings with pre-fabricated roof trusses and brickwork piers enabling an uncluttered open interior space, ideal to manage and store bulk materials

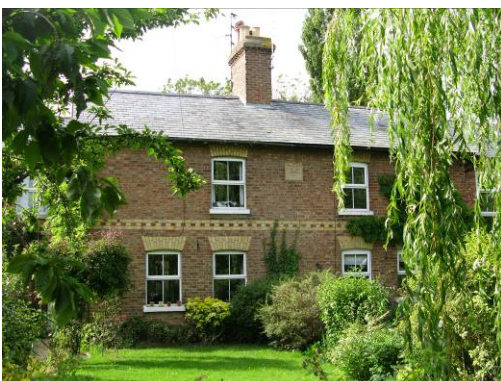
The Victorian approach of symmetrical houses of 2 storeys with a 2 room deep plan form under a shallow pitch slate roof continued into the early 20th century. The red bricks reflect the new self firing brick kilns being introduced in Fletton

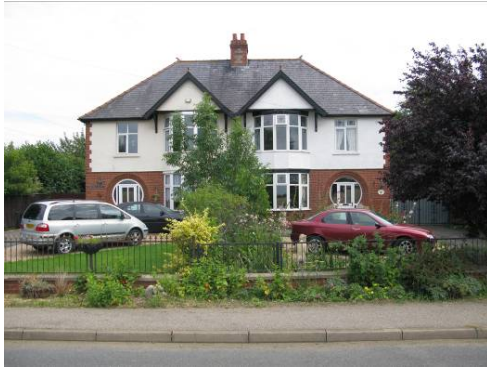
Left, Typical interwar semi with local red bricks but Welsh slate roof and render.

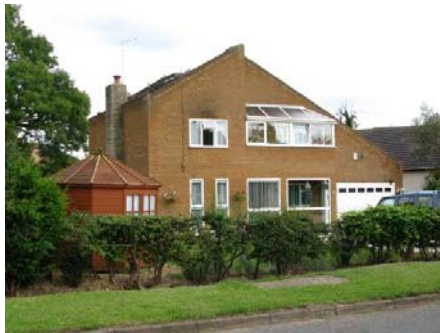
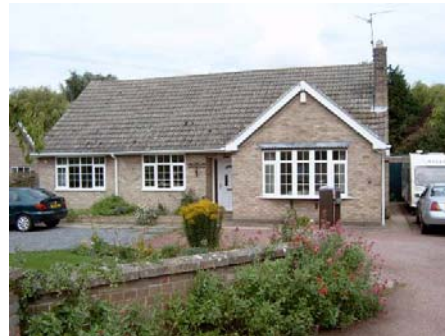
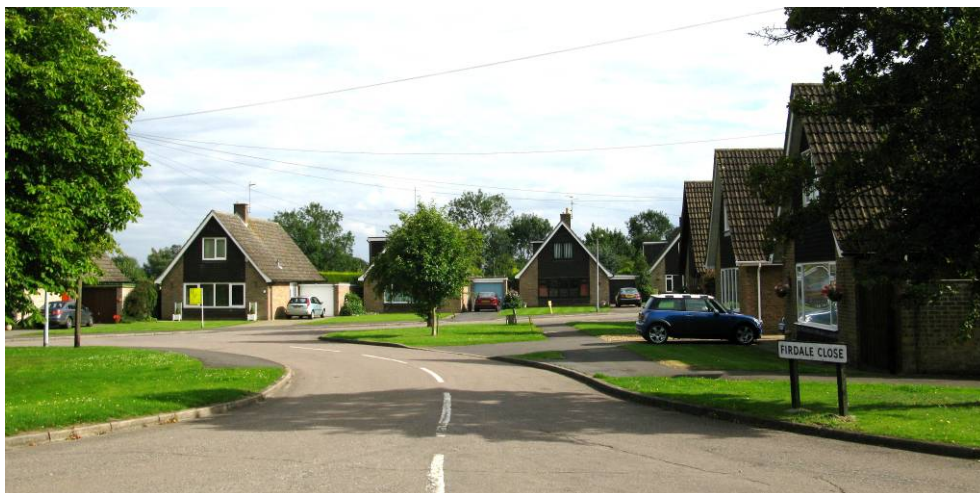
Above, Housing typical of the period 1960 – 1985.

Others, for example the farm buildings and dovecot behind Weststones made way for the new Firdale Close housing estate and the 'ribbon' development along the east frontage to St Pega's Road. This new development reflected the 20th century approach, with buildings uniformly spaced and set back from the frontage with an open front garden. New industrial techniques in brick production meant that the typical local stock bricks used since the 17th century were replaced by hard edged, sand faced bricks produced in almost any colour and texture. Factory made casements replaced sash windows and cladding panels became fashionable. Plastic guttering was cheap and required no painting.

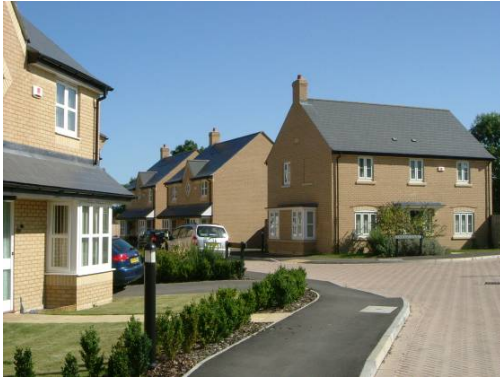
Post 2000 estate development in machine made brick, artificial blue slate.

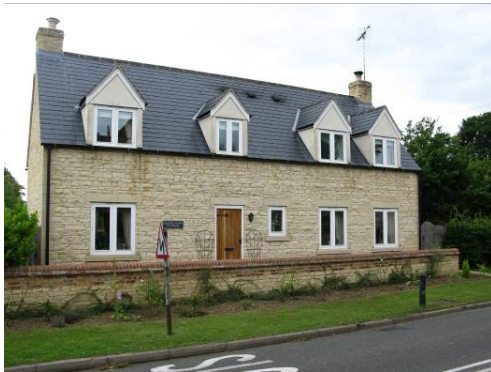
Post 2000 development of individual plots within the conservation area, in stone with natural Welsh slate and good quality artificial Collyweston slates

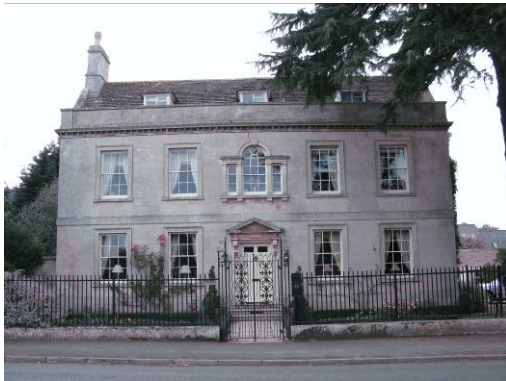
Greystones (now Peakirk House)

The position and grandeur of The Rectory, illustrates the power of the church, well into the 19th century. Greystones is a classic Georgian House and possibly marks the increasing wealth that could be generated by the new breed of land owning farmers, whilst The Grange may reflect the prosperity brought by the railways. The formal nature of these buildings and the quality of their stonework shows that they were designed by the architects and masons of the day to make a statement reflecting the relative prosperity of their owners. The buildings are invariably based on formal plan forms with high floor to ceiling heights, regular, evenly spaced doors and windows and built in good quality stone with Collyweston slate roofs.

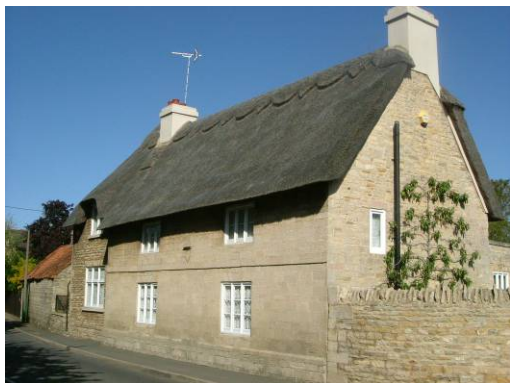
Evidence of remaining buildings and old maps and photographs clearly shows that Peakirk was a mixed farming community and farm buildings including barns, sheds, dovecots, workshops and stores were intensively used. Surviving vernacular farmhouses include The Goshams and Weststones.

These properties are one and a half rooms deep, of two storeys, with strongly rectangular plan forms.

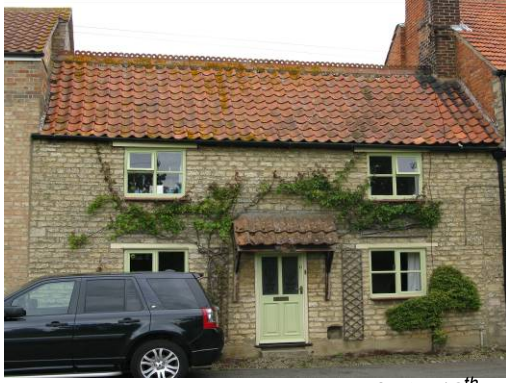
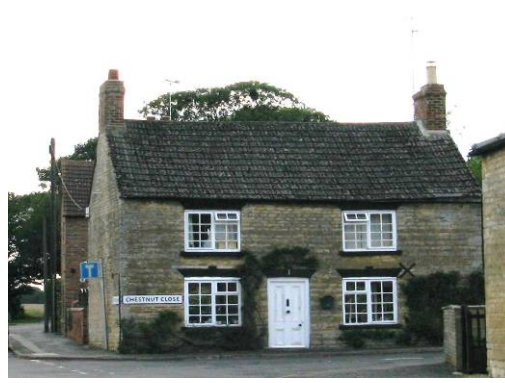
A few cottages from the 18th and 19th century have survived. The general forms are two rooms in width and two storeys in height. These are different from 18th century vernacular buildings in the locality which are generally one room in width and one storey high with attics.

Late 18th c cottages

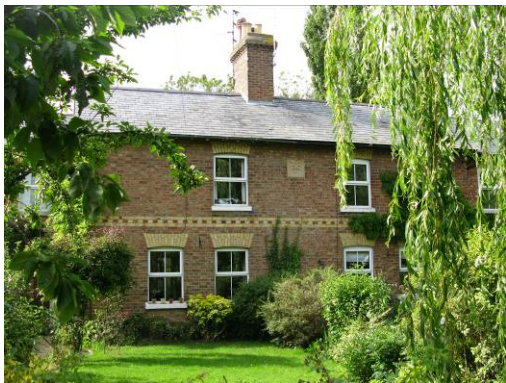
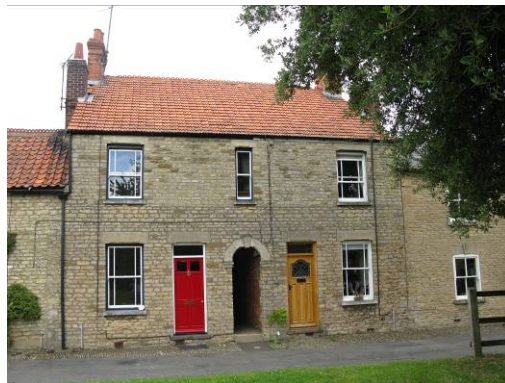
From the mid 19th century, the availability of Welsh slate and quality sawn softwood timber meant that roofs could be much shallower in pitch, so making it possible to build cottages of 2 rooms in depth.

Late 19th and early 20th century cottages

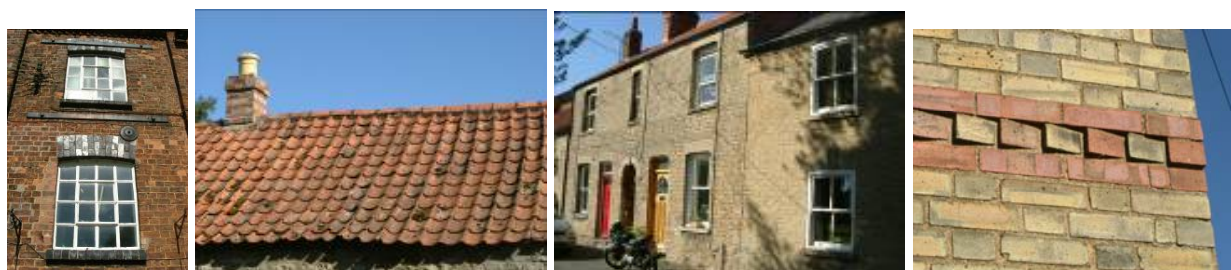
From 1700 to 1900, almost every building was built from local oolitic limestone. Cottages were constructed in rough stone (rubble) laid in strict, but narrow, courses with larger dressed stones (quoins) used on the corners and in window and door reveals. Most had long straw thatched roofs. Long straw is the stalks of the traditional species of wheat that were grown before short stemmed wheat was bred for combine harvesting. Houses were built of better quality dressed stone, laid in wider courses and incorporating stone window sills and heads and other decorative features. Their roofs are in Collyweston slate or thatch. Architect designed houses such as The Rectory and Greystones were constructed in dressed stone with good quality Collyweston slate roofs. Working farm buildings were also all in stone; most have triple or the later single roll clay pantiles though there is some evidence that on farm buildings originating before around 1800 were generally thatched. (see map at annexe 2.3)

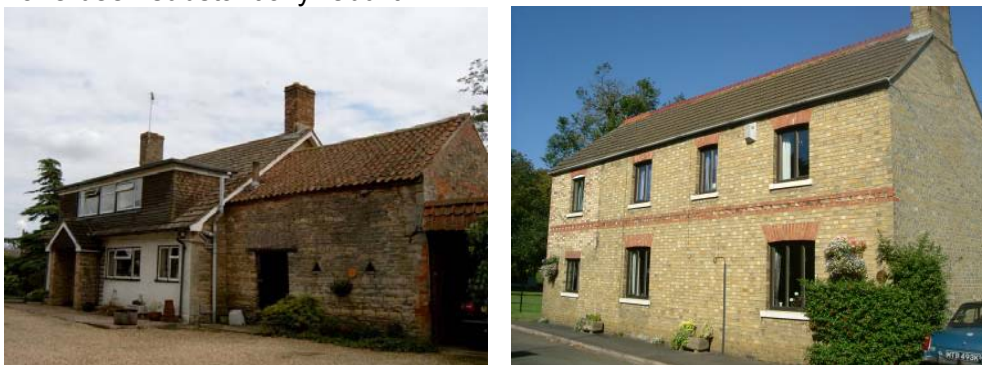
Most cottages have been amalgamated into larger dwellings and/or greatly extended whilst others have been substantially rebuilt.

Early 18th century house substantially rebuilt Late Victorian house extended / reformed in 20th century.

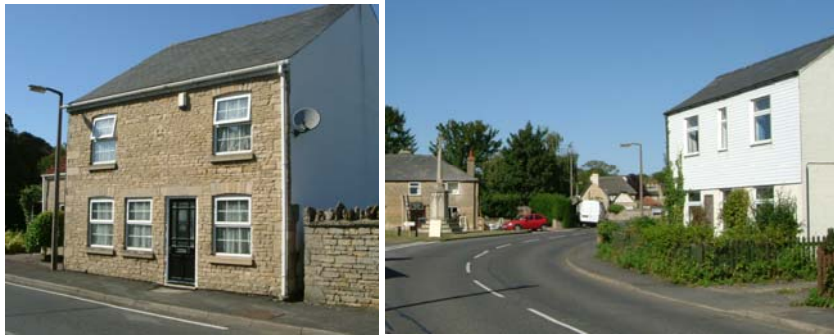
Most pre 20th century small buildings have been greatly altered. Today, there are no windows surviving from before about 1870. Many Victorian cottage sash windows and panelled doors have also been replaced with uPVC windows and former Collyweston, thatch and even Welsh slate roofs have given way to concrete tiles. A number of buildings are rendered or clad and wooden eaves and fascias added to accommodate plastic guttering to replace cast iron.

Impact of PVC replacement windows and cladding

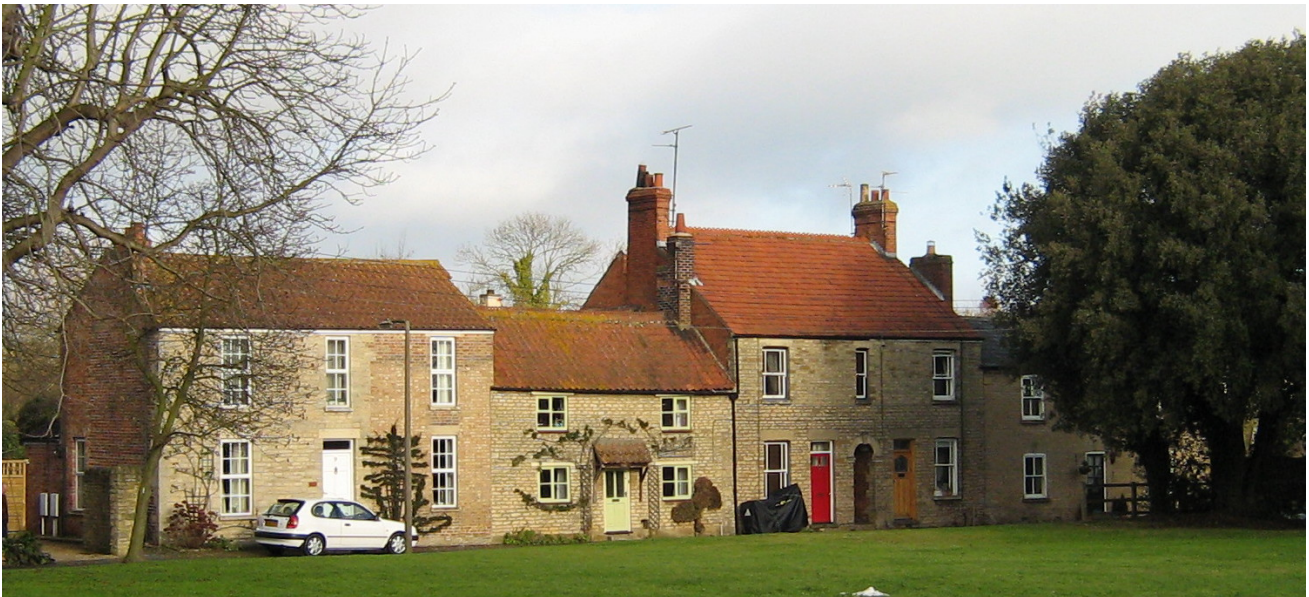
Today, no pre-1870 cottage or small house retains the greater part of original plan, form and features, other than the stone external walls. Late Victorian and houses and cottages retain more original fabric but since these buildings are not subject to planning controls, some visually unsympathetic replacement doors, windows etc have been installed.

Terrace of substantially intact late Victorian cottages, Chestnut Close

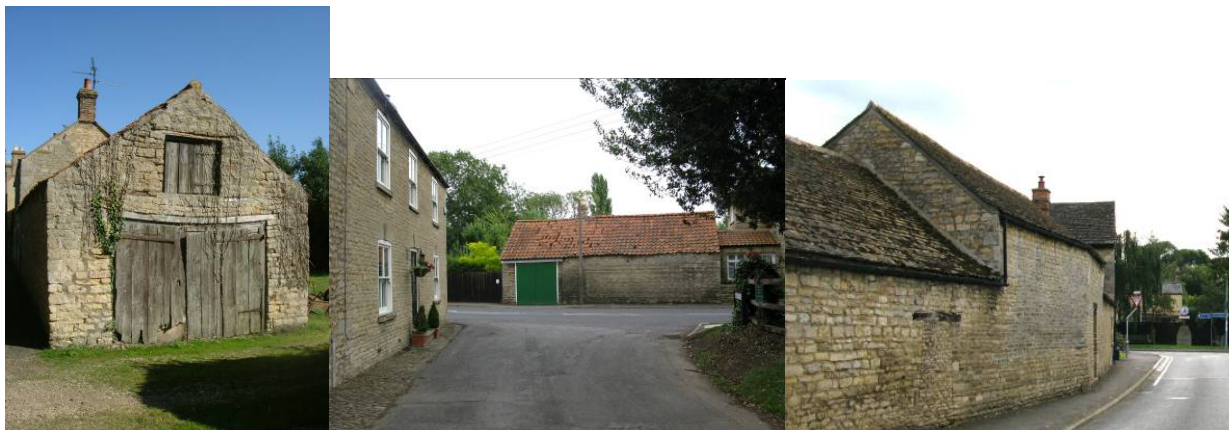
Typical sheds from the 18th and early 19th centuries

There are a number of buildings, particularly the 18th and 19th century sheds that are underused or vacant. It is generally recommended that the best use for historic buildings is that they were originally designed for. However, changing lifestyles means that these buildings are unlikely to retain their original storage / workshop uses.

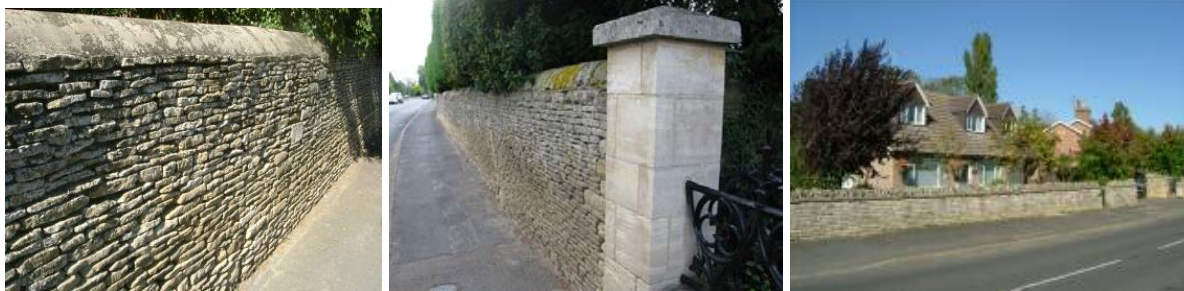
19th century stone walls

- **All existing stonewalls should be retained, maintained and rebuilt if necessary and where there are opportunities (for example as part of a landscaping scheme linked to the grant of planning consent), restored to their original height**
- **The City Council, in conjunction with the Parish Council, English Heritage and other bodies consider ways to assist the repair of existing walls and the building of new walls in the local tradition**

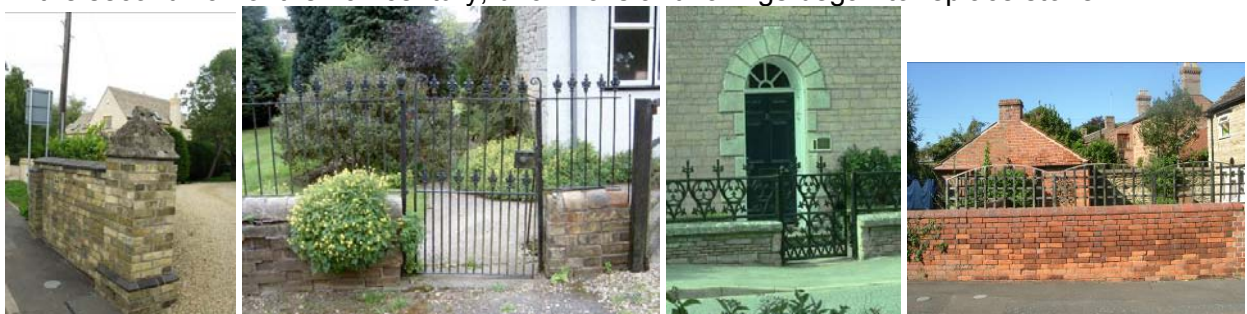
In the second half of the 19th century, brick walls and railings began to replace stone.

19th century walls, gates and railings

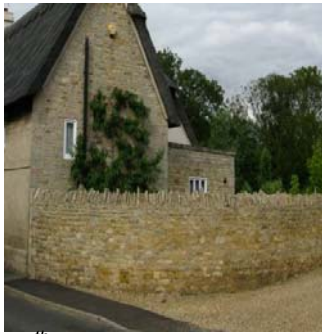
20th century stone wall

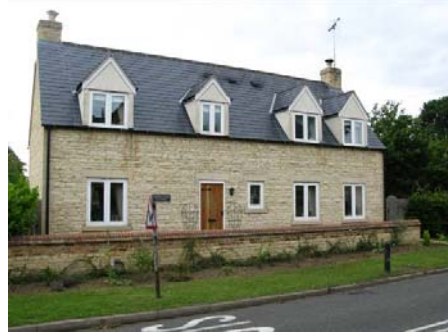
Recent new buildings incorporating new or rebuilt traditional walls.

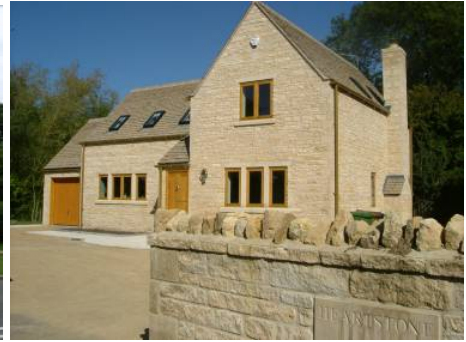
Very few walls were erected in the 20th century. However, since 2000 individual houses have included the building / rebuilding of frontage stone and brick walls.

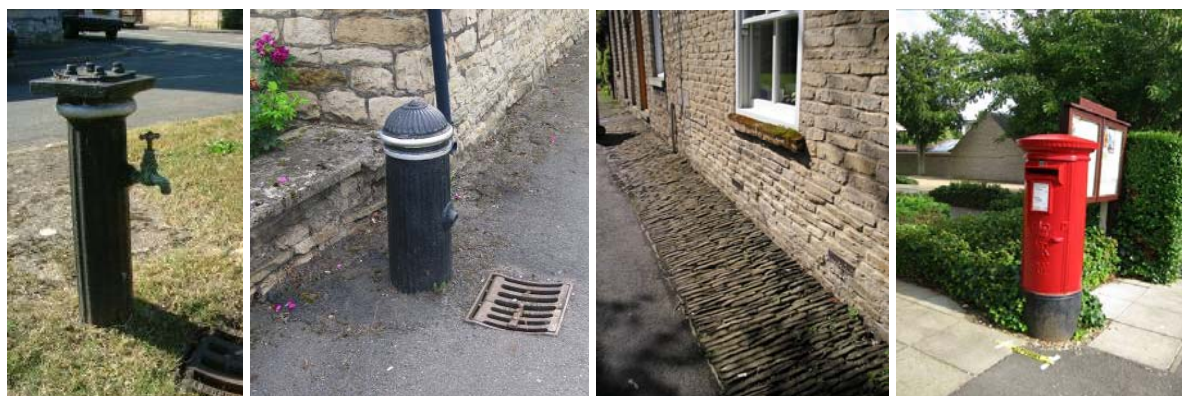
The overall effect of post 1960's highway works and street furniture has lessened the historic character and appearance of the conservation area. However, there is evidence of surviving paths and surfaces from the 19th century. The early 20th century post box and replica iron well pumps also remain.

Replica pump casing

19th c local limestone setts

- **Retain all vestiges of historic street furniture and materials such as old light standards, water pumps, milestones, and granite and local stone kerbs and setts**
- **As up-grading and replacement schemes for streetlights, railings, signage etc come forward, new designs and materials should be chosen to complement the historic character of the Peakirk conservation area**
- **New development should incorporate traditional features such as limestone setts, granite kerbs etc.**
